Job No: 7747/57  
Our Ref: 7747/57-AA-R1  
18 January 2022

re: **Redbank Development – Promenade  
Grose Vale Road, North Richmond  
Site Classification Report**

7747/57-AA-R1  
 Redbank Development – Promenade  
 Grose Vale Road, North Richmond

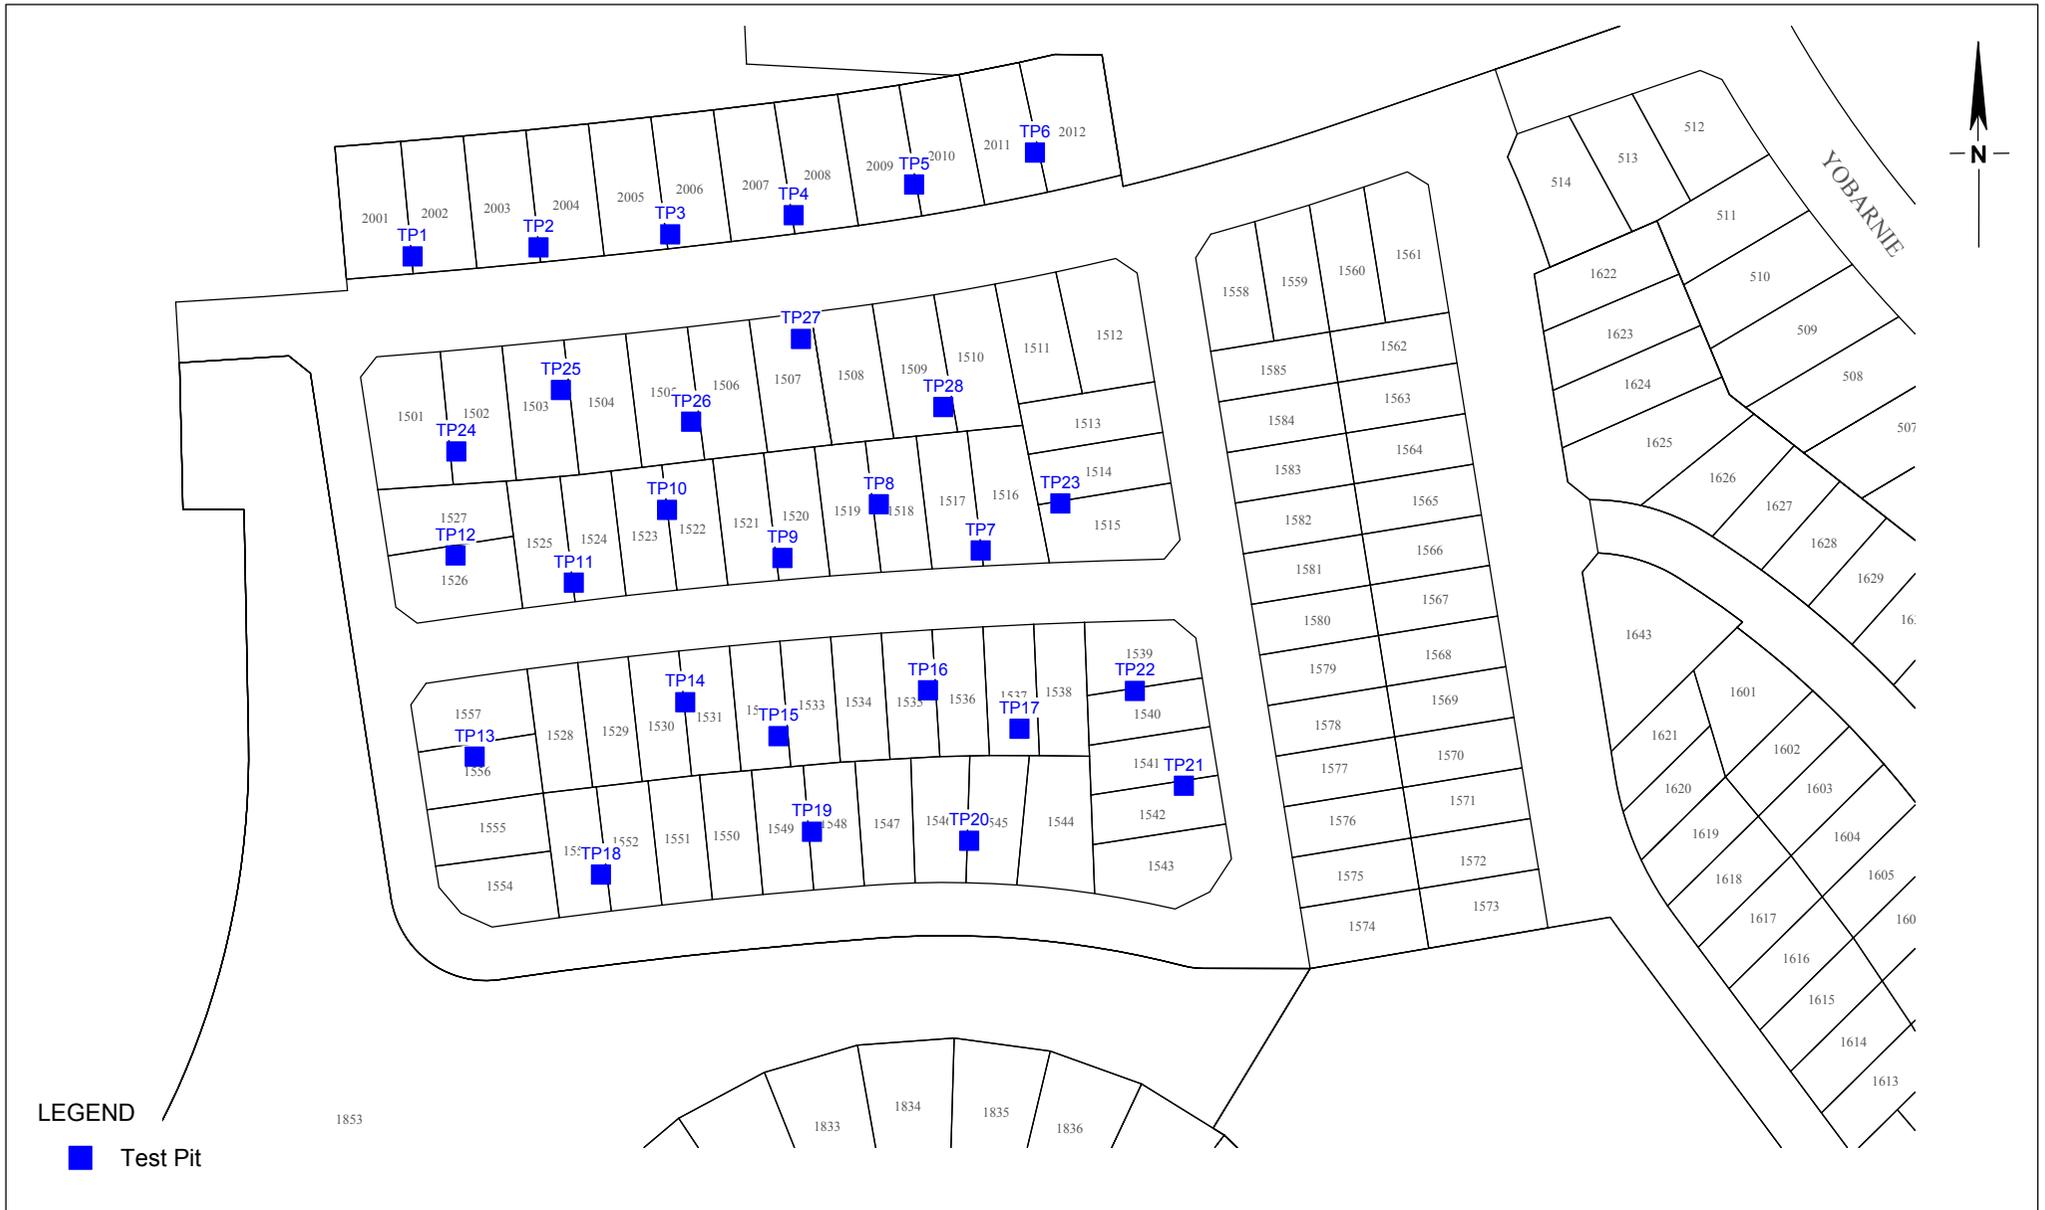
Drawing No: 7747/57-AA1  
 Job No: 7747/57  
 Drawn By: MH  
 Date: 3 December 2021  
 Checked By: ZA

Test Pit Locations

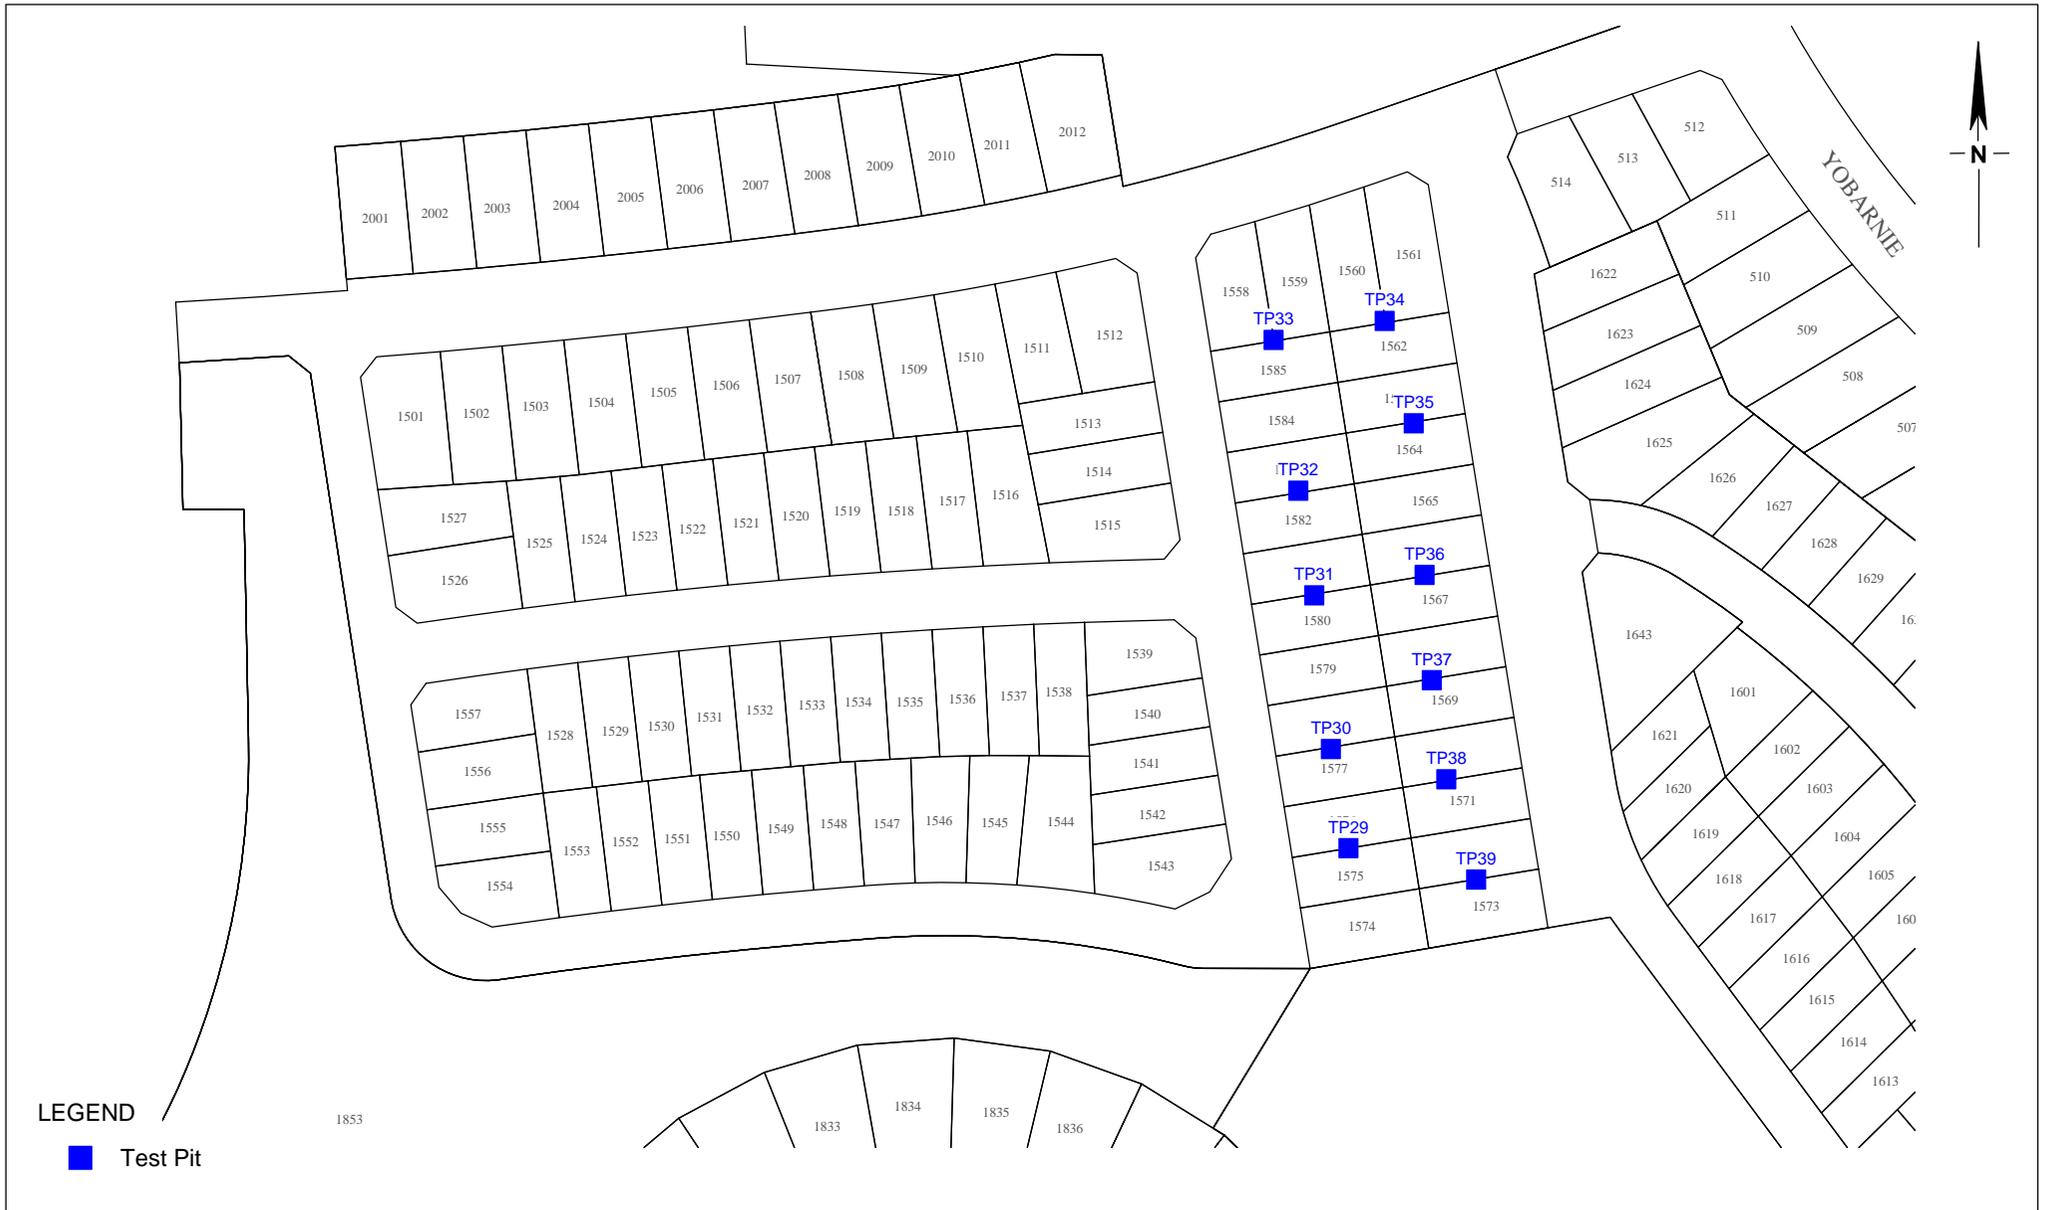
Drawing No: 7747/57-AA2  
Job No: 7747/57  
Drawn By: MH  
Date: 13 January 2022  
Checked By: ZA

Test Pit Locations
